## **Analysis of Baturagung Reservoir Leaking, Gedangrejo, Gunung Kidul Regency using Digital Outcrop Model Method**

### ***Analisis Kebocoran Embung Baturagung, Gedangrejo, Kabupaten Gunung Kidul Menggunakan Metode Digital Outcrop Model***

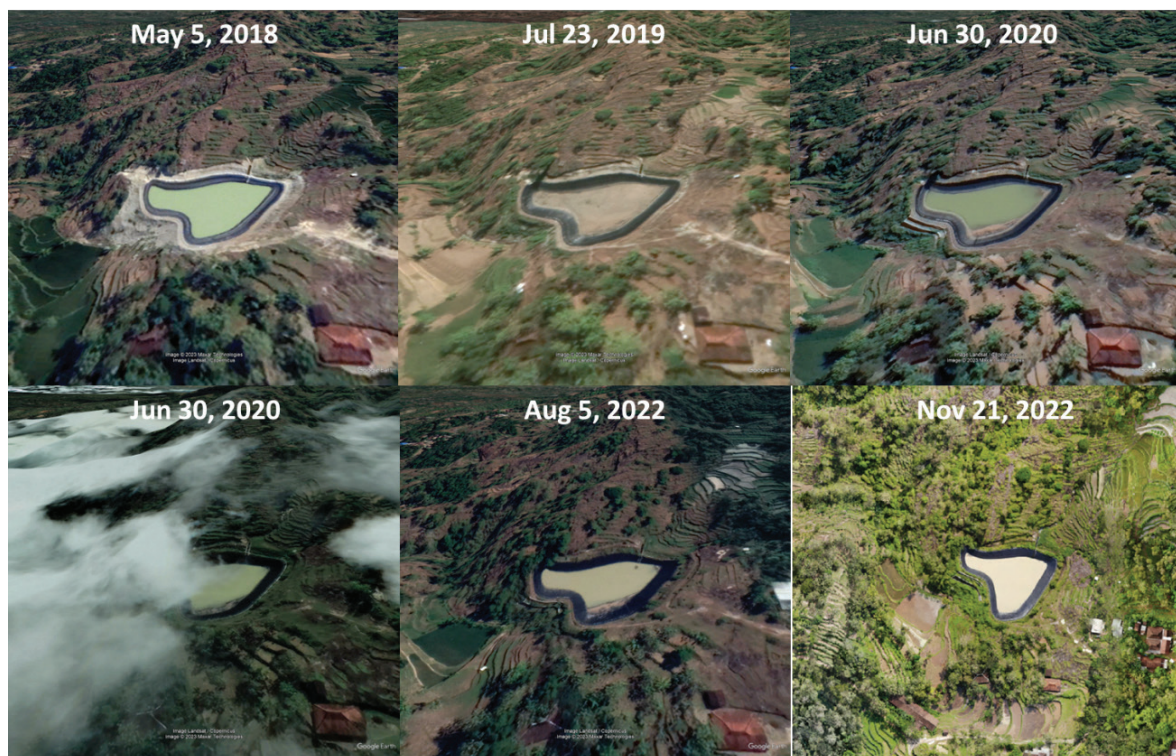
Based on the Google Earth timeline (Figure 1) from 2018 until the latest data collection in November 2022 and local residents, the Baturagung Reservoir has never been completely fulfilled. This evidence makes the author suspect that a geological structure is responsible for the leaking reservoir. In conducting our analysis, the author employs photogrammetry analysis using UAV. Globally, UAVs are used for geological research, and the application of this technology is growing in popularity (Niethammer *et al.*, 2016; Bemis *et al.*, 2014; Nishar *et al.*, 2016). Photogrammetry can generate statistical data about spread and fracture trends, as well as fold trends, directions, types, and axes for the reconstruction of folds. Various studies attempt to establish the same stocky density values at regional, outcrop, and thin-cut scales. Diverse studies explain inevi-

Figure 1. Google Earth timeline from May 5, 2018, to Nov 21, 2022 (collected data).

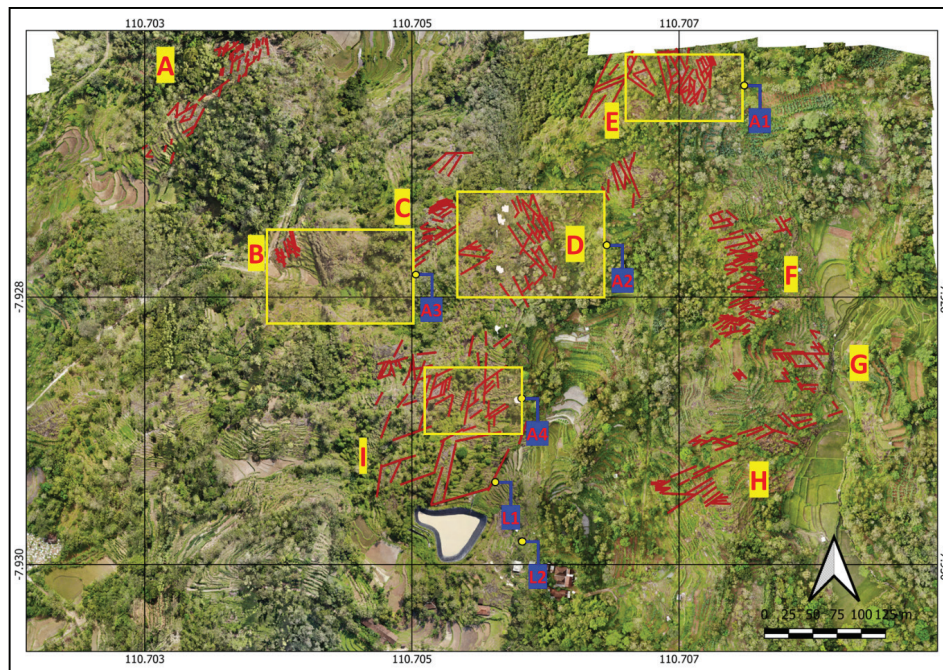
represented using an aerial orthophotograph (Figure 5). The Semilir Formation, as evidenced by the visual representation, proves to be particularly conducive to elucidating structural geological features for our interpretative analysis. Structural geology interpretation was achieved through a synergistic integration of aerial observations and results obtained from ground-based geological observations. The author divided the research area into 9 (nine) segments. A lineation pattern (shown in the red line in Figure 5) characterizes every segment. The lineation or cracks can reveal a four-fold spatial organization: i) random if the fracture arrangement is statistically indistinguishable from random positioning; ii) uniform if the fracture spacing is constant (Nar and Suppe, 1991); iii) trend if the fracture spacing constantly increases or decreases; iv) clustering if the fracture network is characterized by the presence of regions where fractures have an abnormally close fracture spacing. Fracture corridors are the common name for the narrowly spaced segments of fractures (*e.g.*, Peacock *et al.*, 2016; Laubach *et al.*, 2018).

Figure 5. Aerial interpretation clustering for lineation or fracture trend.

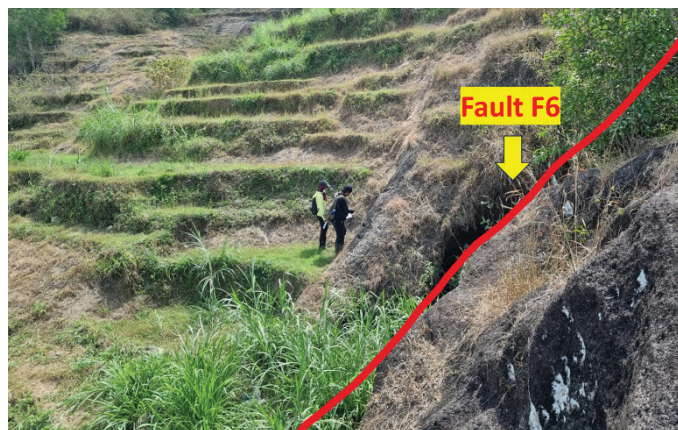
Observation point L1 is located directly north of the reservoir embankment (Figure 5) and is implicated by the author as a potential source of the observed reservoir leakage. Observation point L1 revealed a conspicuous open crack exhibiting an orientation of N025°E. For a more detailed illustration, please refer to Figure 6. Segment I is characterized by fresh Semilir Formation on the western side of Fault F6, while on the eastern side lies a valley composed of weathered rock.

Figure 6. Land observation L1 reveals a fault F6, which is suspected to be the main cause of reservoir leakage.

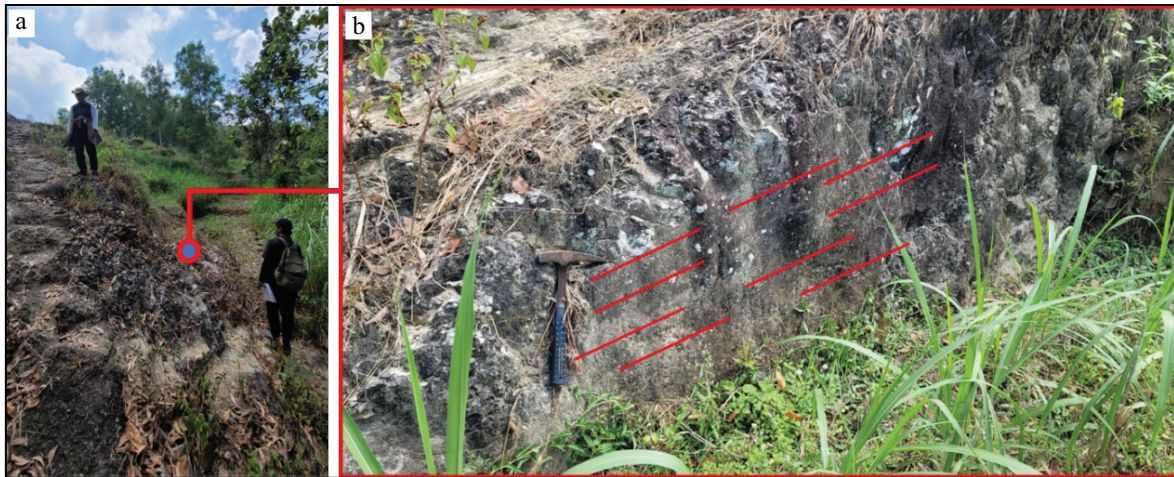
Located east of the Baturagung reservoir (Figure 5), observation point L2 features a fault plane associated with the fault in observation point L1. The damage zone, visible in Figure 7a, indicates

the presence of a fault with an orientation of  $N029^{\circ}E/76^{\circ}$ . On this fault plane, slickensides are observed with a rake of  $32^{\circ}$  (Figure 7b). Based on Rickard (1972), this fault is classified as a Normal Left Slip Fault. Describing the rock, it exhibits a fresh dark gray color, with weathering manifesting as a dark brown hue and coarse-lapillus grain size (0.06-64mm). The rock displays angularity and poor sorting, leading to its description as Lapili at this location.

Figure 7. Land observation L2: a; Damage zone of Fault F6; b; Fault plane with orientation of N029°E/76° and Rake 32°.

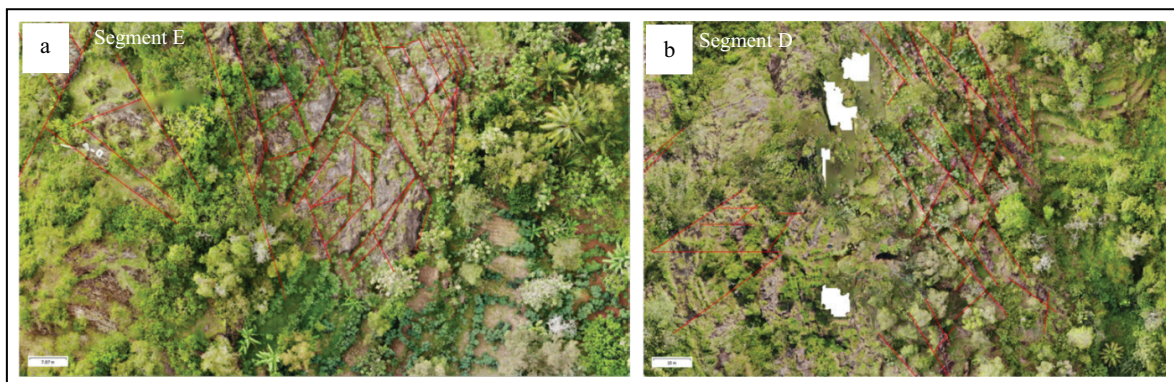
area. Segment E is located in the northernmost part of the study area. By zooming in, it is possible to observe several clearly visible fractures in Figure 8a. Through quantitative analysis of their orientation, it can be concluded that the main direction of these fractures is from  $N155^{\circ}E$  to  $N335^{\circ}E$ , with a total population count of 62. In observation A2 (Figure 8b), we employed a similar approach as in the previous point, conducting a detailed examination by zooming into Segment D. In Segment D, a population of 34 fractures was identified with a primary ori-

entation ranging from 145° to 325°. The clearer zoom-in on Segments E and D is depicted in Figures 8a and 8b.

Figure 8 (a), a zoom-in of Segment E; (b), A zoom-in of Segment D. Both figures depict the population and orientation of fractures for clarity.

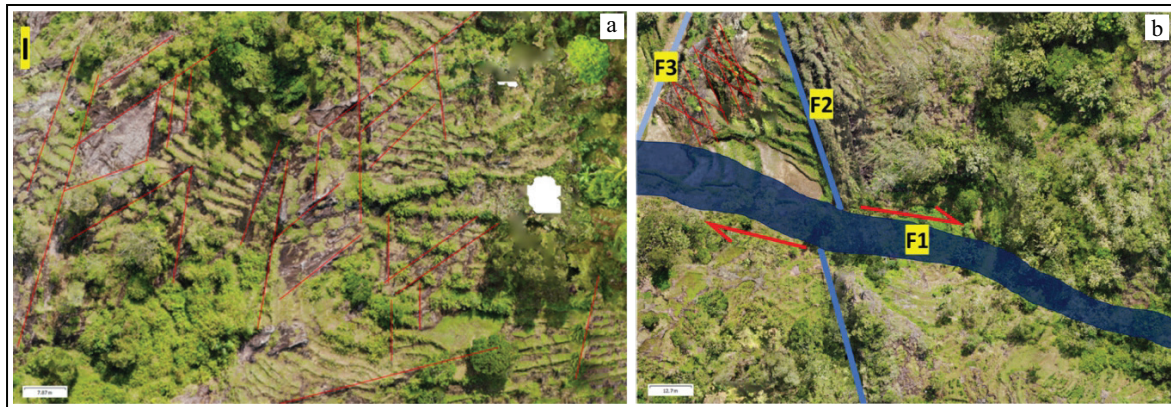
Observation A3 (Figure 9a) involves a zoom-in on Segment I, located north of the Baturagung Reservoir (Figure 5). In this segment, a total of 71 fractures were identified, showing main orientations ranging from 015° to 195° and 070° to 250°. For a comprehensive overview, the rosette diagram depicting Segments A to I is presented in Figure 12, and the population and trends of fractures from Segments A to I can be referenced in Table 3.

In Figure 9b, an offset is observed, indicating a faulting event where the northern part of fault F1 has relatively moved to the right compared to the southern portion of fault F1. Apart from in-

tersecting both the northern and southern blocks, fault F1 also intersects with fault F2. Based on the offset movement, it can be concluded that fault F1 is a right-lateral strike-slip fault.

Figure 9 (a): A zoom-in of Segment I present population and orientation of fractures; (b) presents an offset of fault F1.

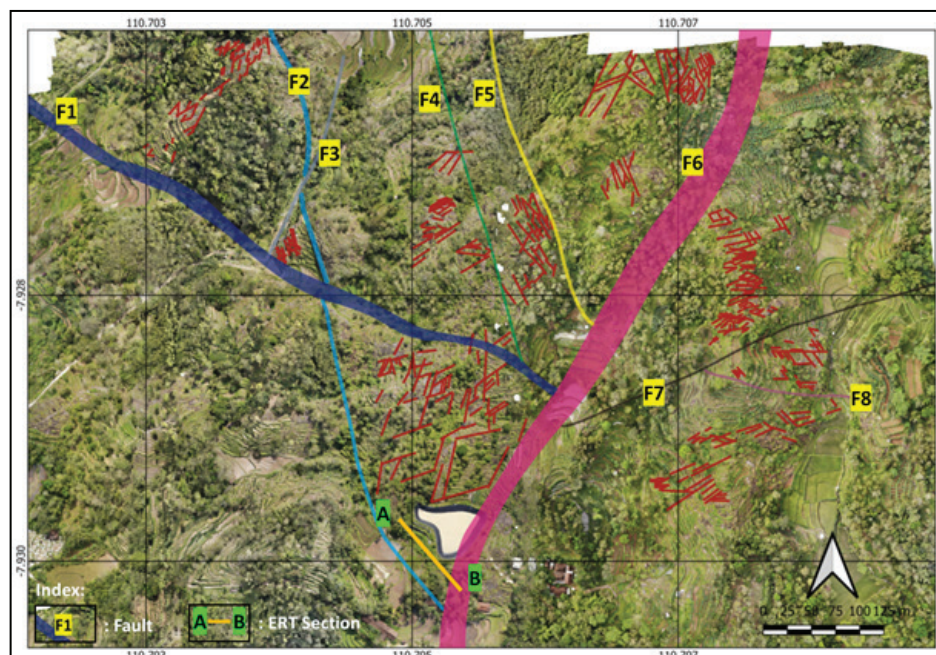
Figure 12. Geological structure map of the research area.

major fault, has an NNE - SSW direction with a major damage zone. Through line A-B in Figure 12, our interpretation reveals the F6 fault damage zone, leading to leakage in the Baturagung Reservoir (Figure 13b). The analysis highlights that a lack of understanding of geology can contribute to the failure of water storage in the Baturagung Reservoir, which is attributed to the fault.

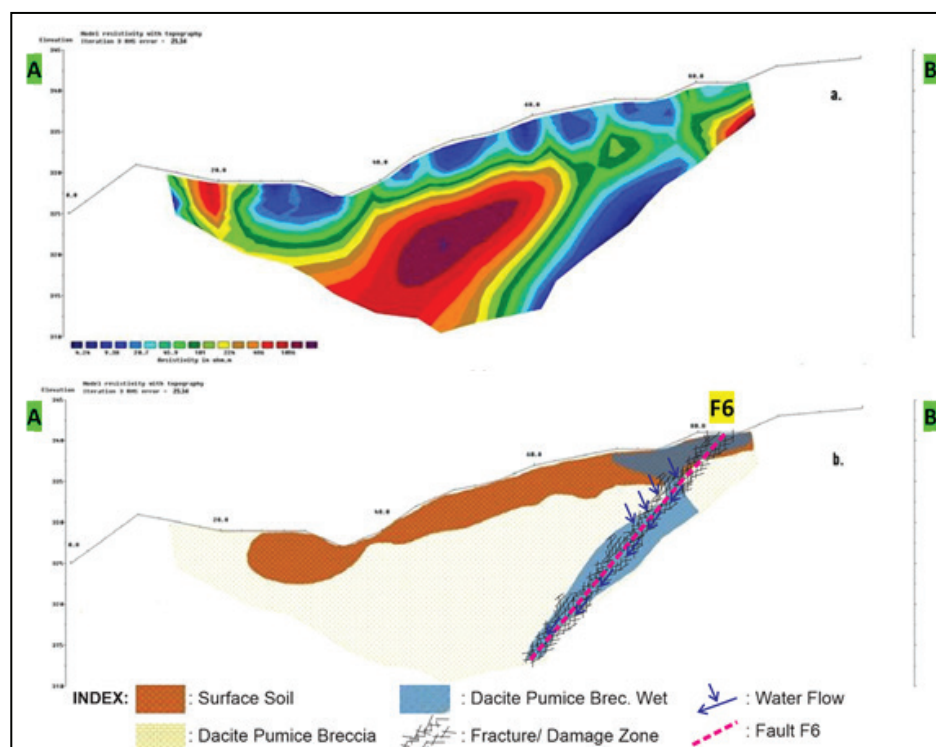
In this section, we use modified ERT (Electrical Resistivity Tomography) in Figure 13a from Zakaria *et al.* (2023) data for sub-surface interpretation to understand how Baturagung Reservoir leaks due to a damaged fault zone of F6. The results of the ERT method are variations in resistivity values along the measurement lines. This resistivity value will be interpreted as the rock and water content type. The 100 m measurement line southwest of the reservoir exhibits a direction of N135°E. Inversion results indicate a range of resistivity values from 4.24  $\Omega\text{m}$  to 1096  $\Omega\text{m}$ . Low resistivity values (4.24  $\Omega\text{m}$  to 45.9  $\Omega\text{m}$ ) dominate the surface, representing the response of subsurface soil (depicted in brown in Figure 13a) up to a depth of 5 m. Between 5 m and 30 m depth, high resistivity values (45.9  $\Omega\text{m}$  to 1096  $\Omega\text{m}$ ) prevail, corresponding to the Dacite pumice breccia. This breccia, visible on the surface at the line's beginning, is a reference for high resistivity values. At the 70-80th m of the line, a low resistivity value emerges (4.24  $\Omega\text{m}$  to 20.7  $\Omega\text{m}$ ), interpreted as the impact of reservoir leakage. The leakage is attributed to fractures in the Dacite pumice breccia, serving as conduits for water southwest of the reservoir, resulting in decreased resistivity values.

Figure 13. Interpretation of resistivity values on ERT lines A – B (Modified from Zakaria *et al.*, 2023): (a). The result of inversion of field data into actual resistivity; (b). The result of interpretation of resistivity values into rock types and water content. Sub-surface interpretation of Baturagung Reservoir and its surroundings shows that the damage zone of Fault F6 causes the leaking of Baturagung Reservoir.
