## **Analysis of Baturagung Reservoir Leaking, Gedangrejo, Gunung Kidul Regency using Digital Outcrop Model Method**

### ***Analisis Kebocoran Embung Baturagung, Gedangrejo, Kabupaten Gunung Kidul Menggunakan Metode Digital Outcrop Model***

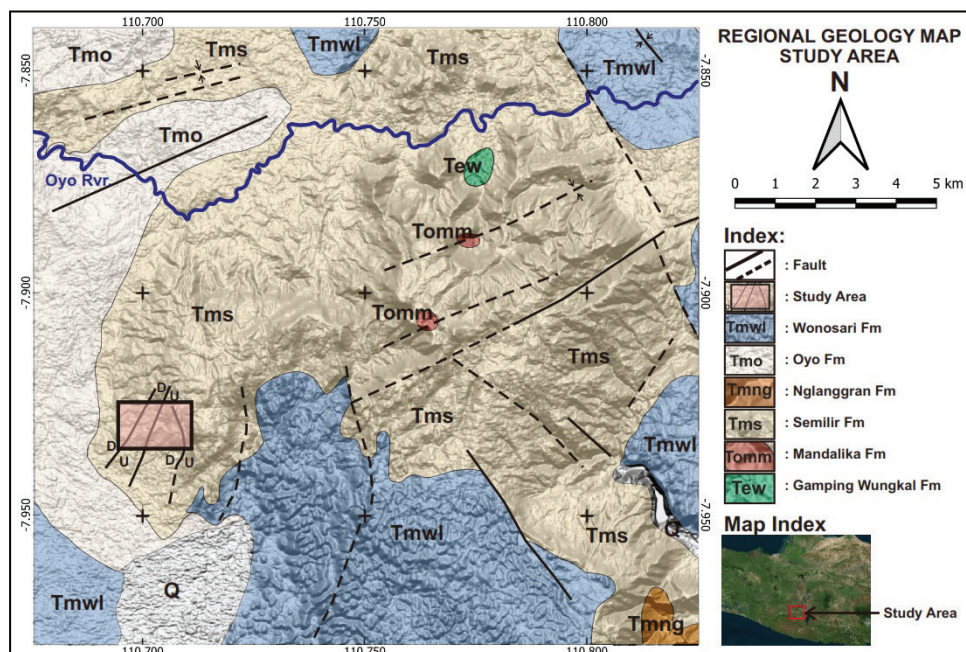
Figure 2. Regional Geological Map of Study Area (Modified from Surono *et al.*, 1992).

on Surono *et al.* (1992) in Figure 2, the study area is interpreted as NW - SW structure. This interpretation strengthens the author's belief that a geological structure causes a reservoir leak.

The research method uses visual interpretation and quantitative analyses (statistics). The study reference uses the Geological Map of Surakarta and Giritontro quadrangle sheet (Surono *et al.*, 1992) in Figure 2. The Geological map (Figure 2) shows the study area inside the NE - SW fault zone. As seen in Figure 3, the results of the orthophotograph are suitable for use as a basis for interpretation. The complete results of the photogrammetric process in this study can be seen in Table 2.

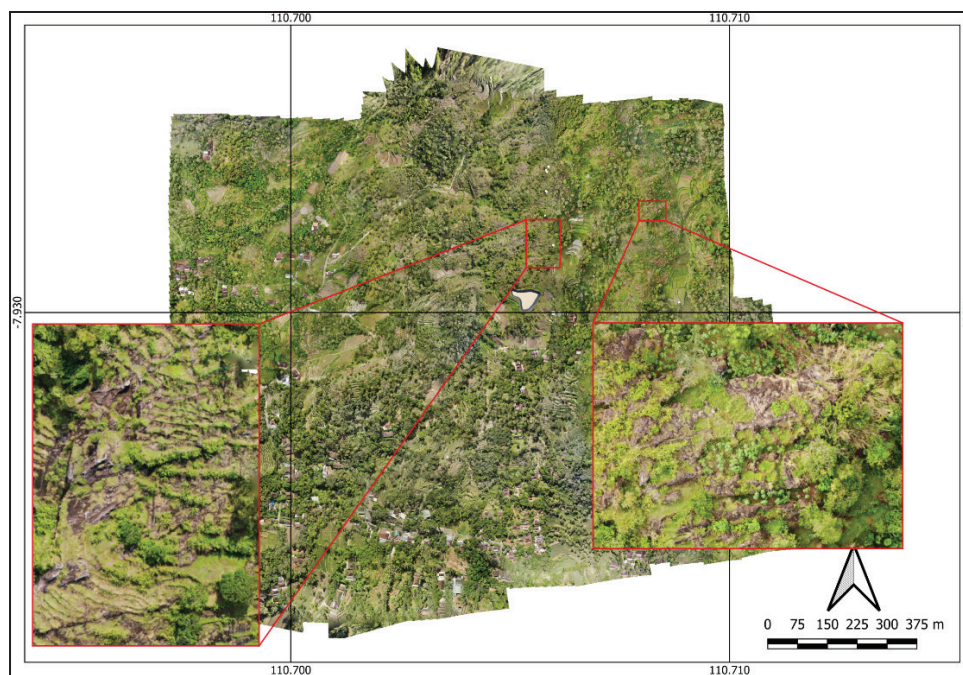
Figure 3. Digital Outcrop Model (DOM) results, the geological structure is visible and appropriately interpreted.

The Digital Outcrop Model result of data processing, as we explained in the previous subchapter, is quite good, and the data is appropriate to be interpreted (Figure 3). Data modeling requires: 1) Model interpretation requires regional geology data and previous studies to support research data. The data needed are regional geological maps compiled from Surono *et al.* (1992) and electrical resistivity tomography (ERT) geoelectrical measurements (Zakaria *et al.*, 2023). 2) Structural Geology analyses and modeling. The author conducted lineation measurements based on the Digital Outcrop Model (DOM) features from aerial data and performed field measurements accompanied by rock descriptions in the study area. The use of aerial DOM allowed the author to cover a broader area for interpretation and analysis purposes. 3) Model interpretation for proving the hypothesis and analyses. The full workflow for methodology can be seen in Figure 4.

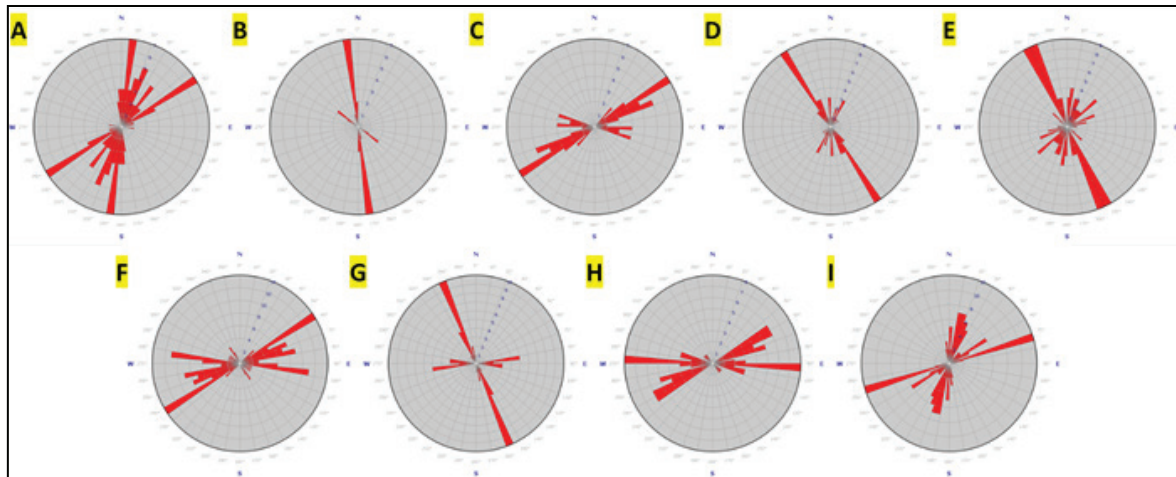
Figure 10. Rosette diagram on a study area showing segment has different trend characteristics.

fault can become a boundary between segments. Some faults can be seen visually through aerial photography or ground observation. Statistical analysis was carried out using a rosette diagram (Figure 10). Each segment has different trend characteristics (Table 3).
